## REPAIR INSTRUCTIONS - P217/P218/P219/P220/P221/P227/P230 PUMPS

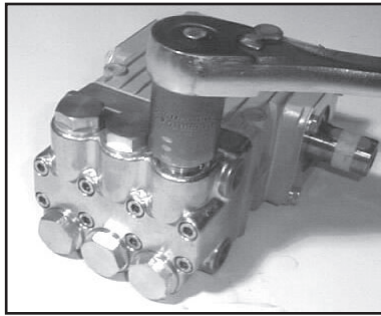
1. With a 22mm socket wrench, remove the (3) discharge valve plugs and (3) inlet valve plugs (32). Inspect the o-ring (33) for wear and replace if damaged.

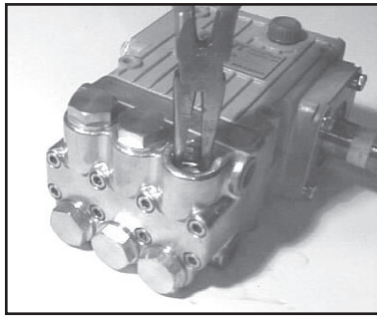
2. Using a needle nose pliers, remove the inlet and discharge valve assemblies (32X).

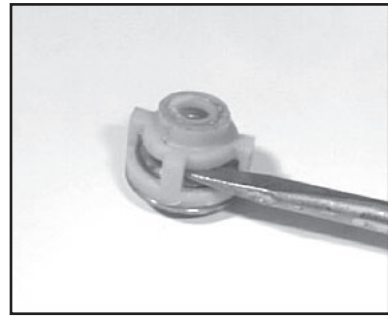
3. By inserting a small screw driver between the valve seat (27) and the valve spring retainer (30), the valve assembly can be separated.

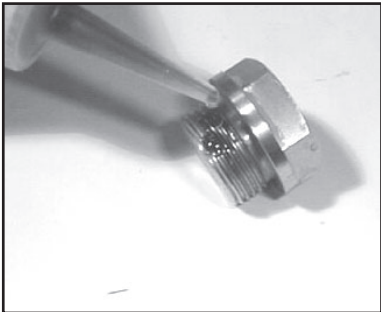
4. Remove the o-ring (31). Inspect all parts for wear and replace as necessary. Apply one drop of Loctite 243 to the valve plugs (32) and tighten to 55 ft.-lbs. (75 Nm)

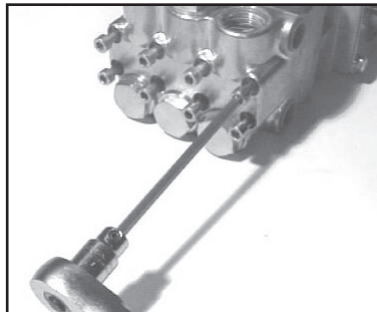
5. Next, use a 5mm allen wrench to remove the 8 socket head cap screws (34).

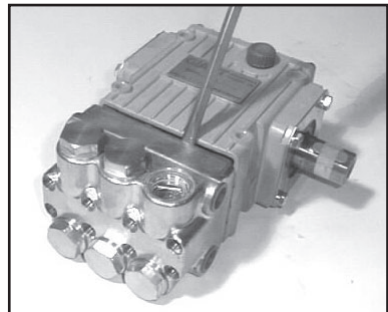
6. Carefully slide the valve casing (26) out over the plungers.

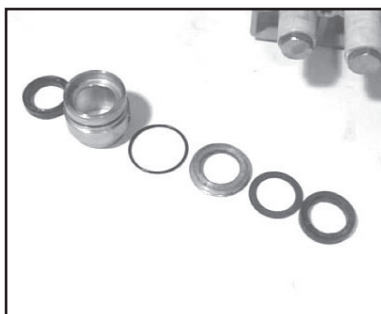
7. Remove the weep return ring (25), pressure ring (24), and v-sleeve (23) from the valve casing (26). Remove the v-sleeve (23A) from the seal case (20). Inspect all parts, including o-ring (21) for wear and replace as necessary

8. Check surfaces of plunger (16). A damaged surface will cause accelerated wear on the seals. Deposits of any kind must be carefully removed from the plunger surface. A damaged plunger must be replaced!

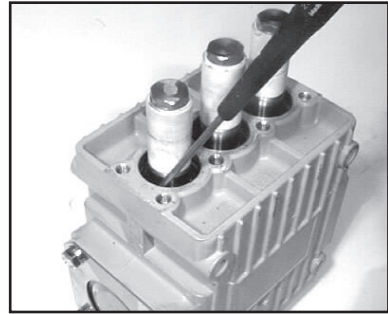
9. If the crankcase oil seals (19) are to be replaced, they can be removed by prying loose with a flat screwdriver. Take care not to make contact with the plunger.
